Manhole Inspection Summary

Manhole # S25K__003MH

Insp Date: 1/30/09 1:13 PM

Location Address: **1223 W. Pratt**

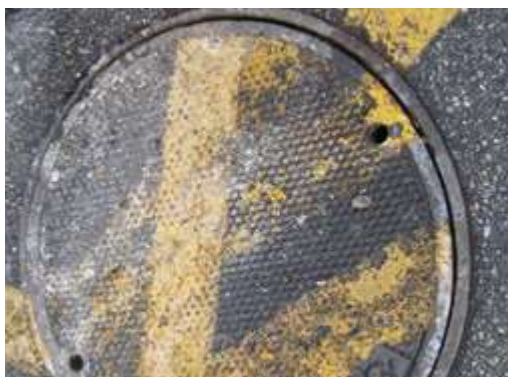
Misc

Condition: **Worn**

cover

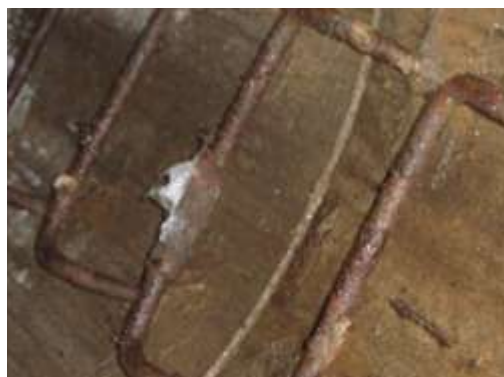
Defect 4

Surcharge ☒ **Evidence Of Surcharge** Depth: **7** (ft.) ☐ Active Surcharge Present

surcharge evidence 7 feet

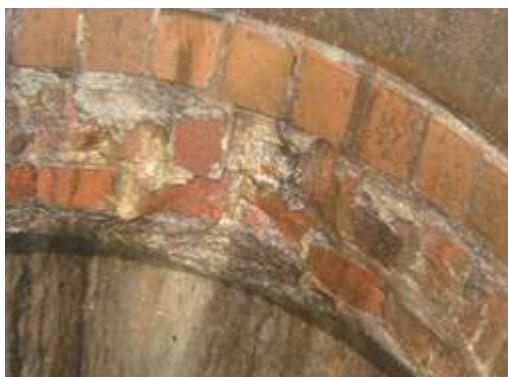
Defect 3

☒ **Leaks**

Condition: ☐ Sound ☐ Cracked ☐ Root Intrusion ☒ **Loose Brick** ☐ Deteriorated

Infiltration: ☐ None ☐ Joint ☐ Cracks ☐ Mortar ☐ Roots ☒ **Wall**

frame infiltration at cover, chimney loose bricks and infiltration at wall

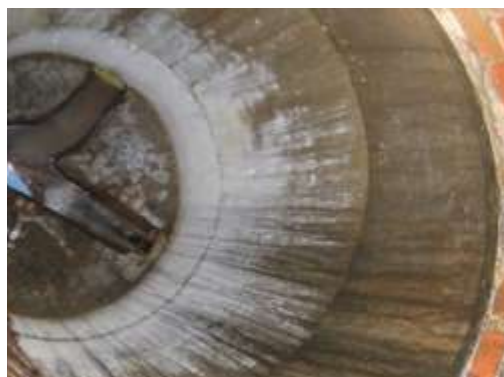
Defect 2

Infiltration: ☐ None ☐ Joint ☐ Cracks ☐ Mortar ☐ Roots ☒ **Wall**

corbel infiltration at wall

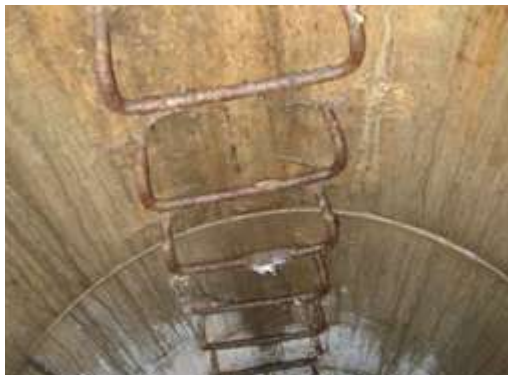
Defect 1

Steps Count: **9** Missing: **0** ☒ **Corroded**

steps corroded

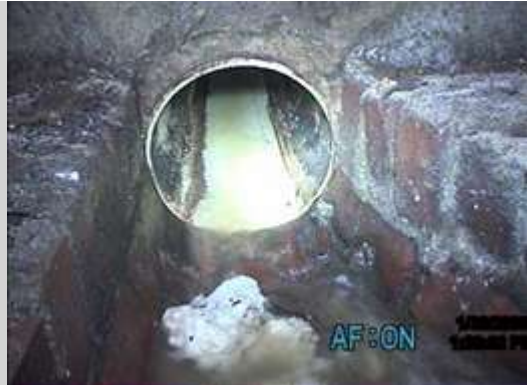
12 O'Clock Outflow

Pipe Height: **8.4** (in.) Rod and Bar (Angled)
Pipe Material: **PVC** ☐ Pipe Lined
Invert Depth: **12.00** (ft.) Flow Characteristics: **Fast**
Deposits: ☒ None ☐ Mud ☐ Sludge ☐ Debris ☐ Grease
Silt Depth: **0** (in.) Deposits Extent:
Infiltration: **None** Pipe Seal Cond: **Sound**

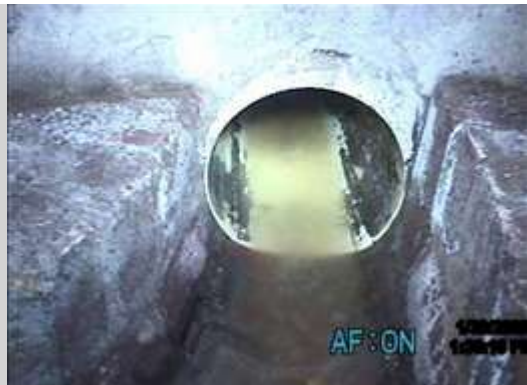
3 O'Clock Inflow

Pipe Height: **8.4** (in.) Rod and Bar (Angled)
Pipe Material: **Clay** ☐ Pipe Lined
Invert Depth: **11.90** (ft.) Flow Characteristics: **Fast**
Deposits: ☒ None ☐ Mud ☐ Sludge ☐ Debris ☐ Grease
Silt Depth: **0** (in.) Deposits Extent:
Infiltration: **None** Pipe Seal Cond: **Sound**

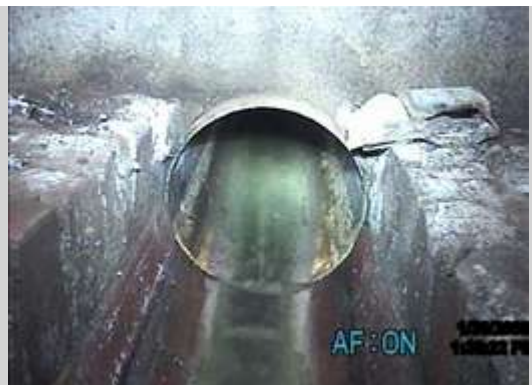
6 O'Clock Inflow

Pipe Height: **8.4** (in.) Rod and Bar (Angled)

Pipe Material: **Clay** ☐ Pipe Lined

Invert Depth: **11.93** (ft.) Flow Characteristics: **Fast**

Infiltration: **None** Pipe Seal Cond: **Sound**
